PROJECT PROFILE

PROJECT: Heathrow Airport - Taxiway
LOCATION: United Kingdom

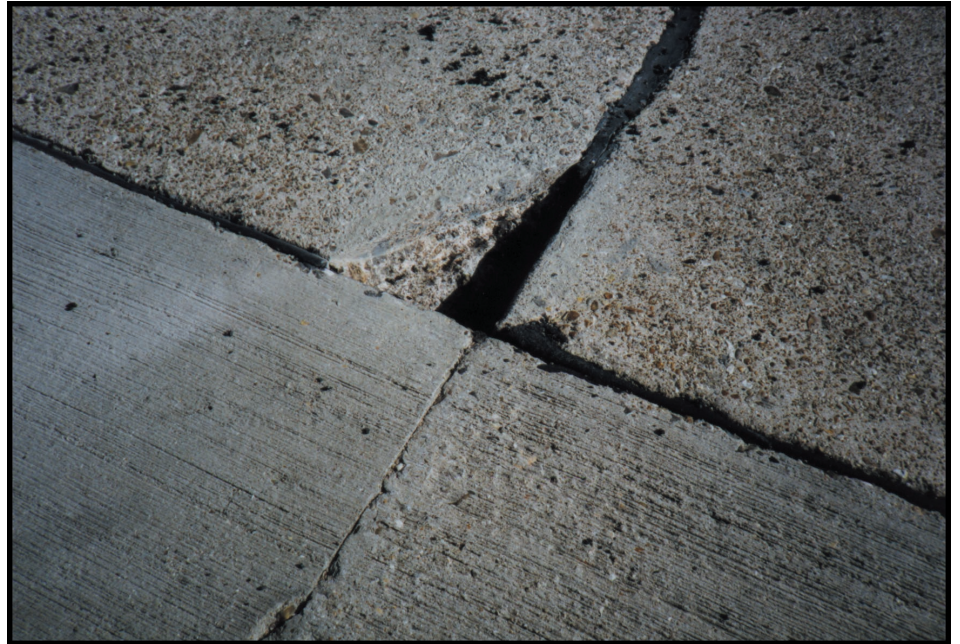
The airport was suffering from the continual breakdown and chipping of the arris edges of the concrete slabs on the taxiway where they are jointed. This was a continual problem due to the compressive forces of the aircraft nosewheels and the added problem of extreme weather cycle exposure. Extensive areas were in need of repair and being one of the busiest airports in the world, the timescale was limited.
