PROJECT PROFILE

PROJECT: Heliport Repair
LOCATION: Germany

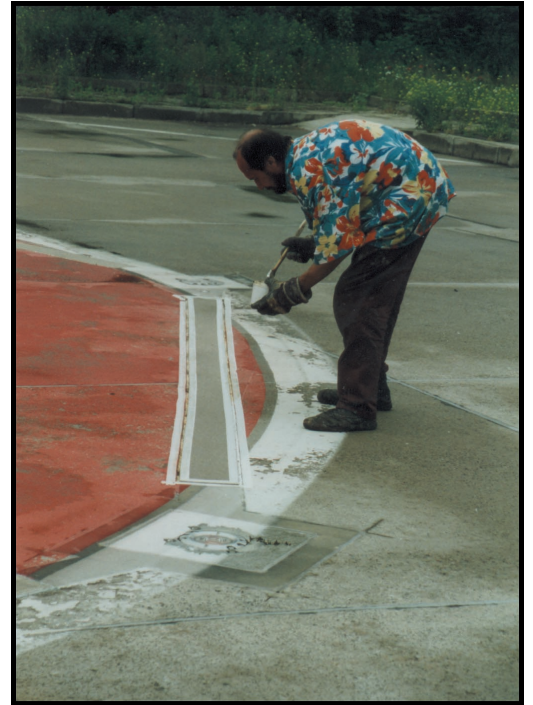
The lights and cables around the landing area were in need of replacing. The heliport could only be out of use for a short period and a repair system that would cause minimum disruption was required.

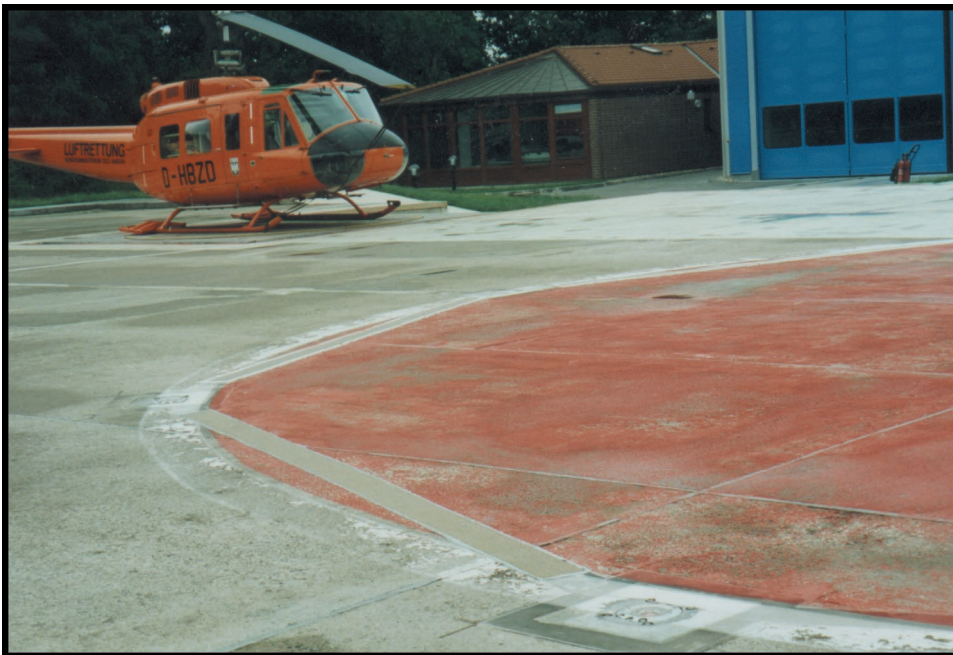
All damaged and loose concrete was removed and channels 20cm wide and 10cm deep were formed in the concrete.

The cables were replaced and the damaged areas were rebuilt with Grano-Tech.

This repair caused minimum disruption and after a few hours, the heliport was back in service.
