PROJECT PROFILE

PROJECT: Bonded Warehouse, Gatwick Airport
LOCATION: United Kingdom

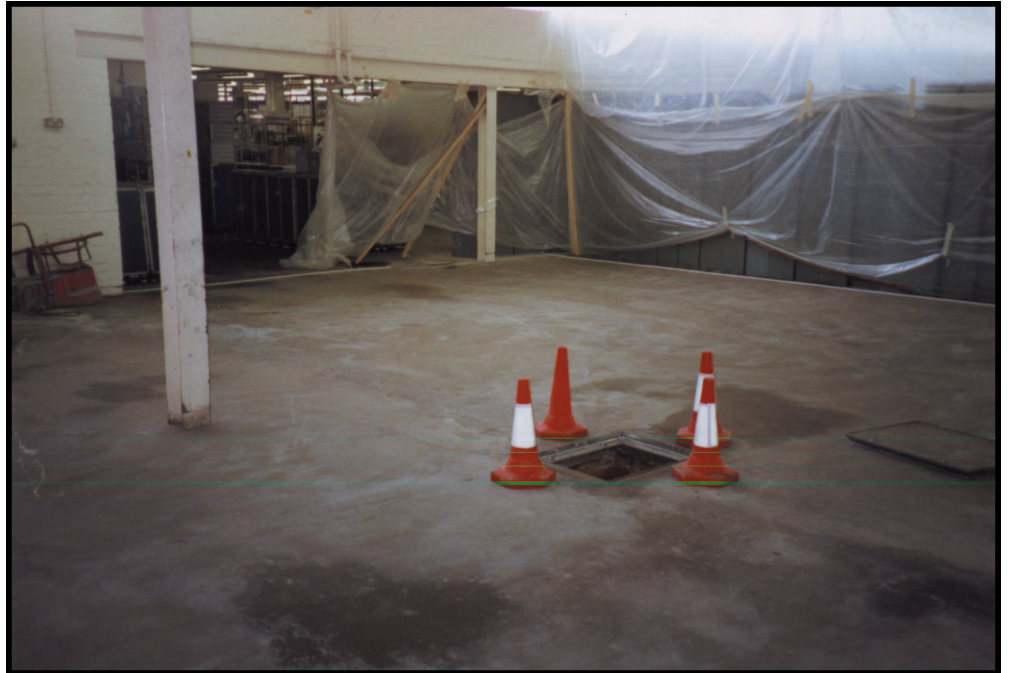
British Airports Authority had a major problem in their bonded warehouse with the floor. After several years use the floor had started to break up, especially at the expansion joints. The floor was also uneven which was causing a potential trip hazard, as well as making the movement of loaded hostess trolleys extremely difficult. The area in need of protection was in excess of 2,000m².
