PROJECT PROFILE

PROJECT: Hangar Floor Protection
LOCATION: United Kingdom

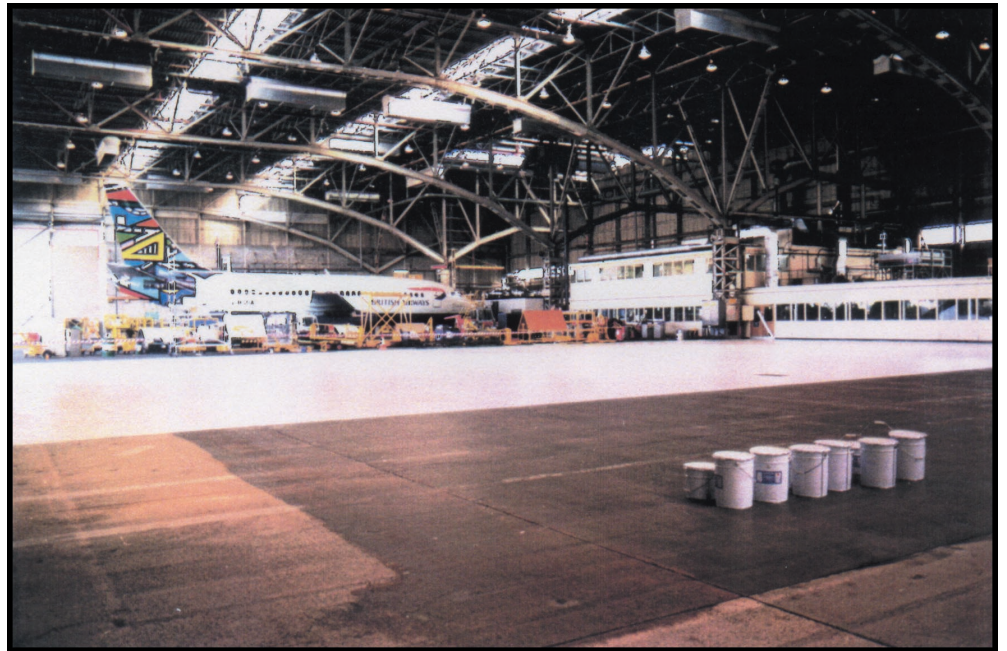
These photographs show hangar three at Gatwick Airport.

The existing coating was in poor condition and had been badly attacked by skydrol fuel.

The whole hangar floor required protection to improve its condition and also give greater light to the hangar.

The areas of floor that were most badly damaged were rebuilt with Floor-Tech RS.

The hangar floor was then coated with Floor-Tech SP Primer followed by Floor-Tech HB.
