## PROJECT PROFILE

**PROJECT:** Refurbishment of External Plastisol Sheeting  
**LOCATION:** United Kingdom

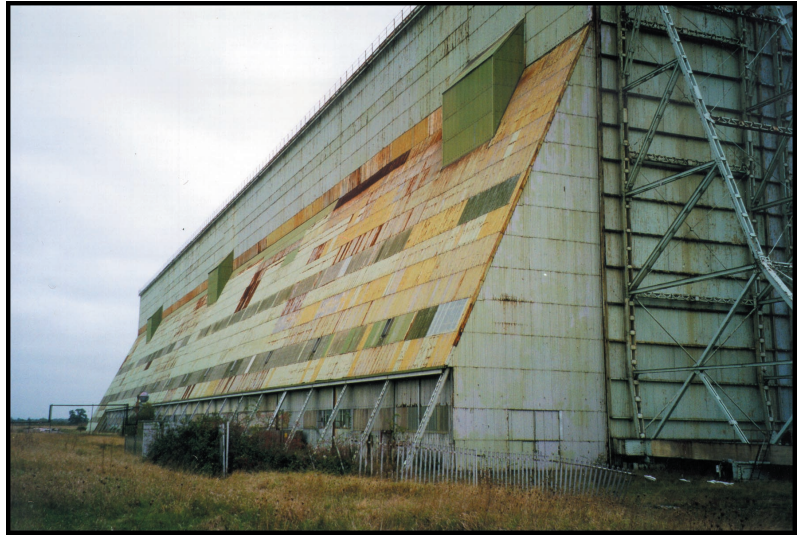
As the photograph shows, the external plastisol sheeting was now degrading badly and in need of immediate refurbishment.

The entire building was first cleaned to remove all contamination and ensure a sound substrate was left.

All areas where rusting had occurred were first treated with Corro-Tech GP. All exposed metal areas were coated with Uni-Tech MC Primer and the complete hangar was then coated with one coat of Wall-Tech PU.

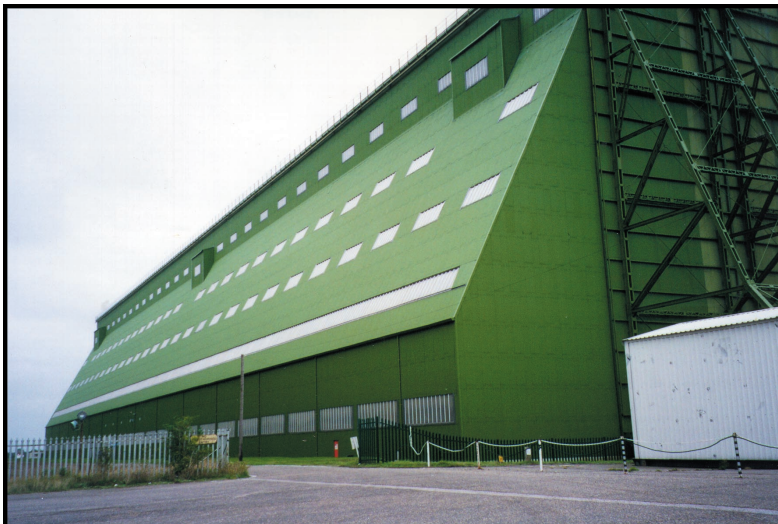
As is clear from the photograph, the application of Thortex products has completely refurbished the hangar.
