PROJECT PROFILE

PROJECT: Hospital Emergency Staircase - Corrosion Protection
LOCATION: Spain

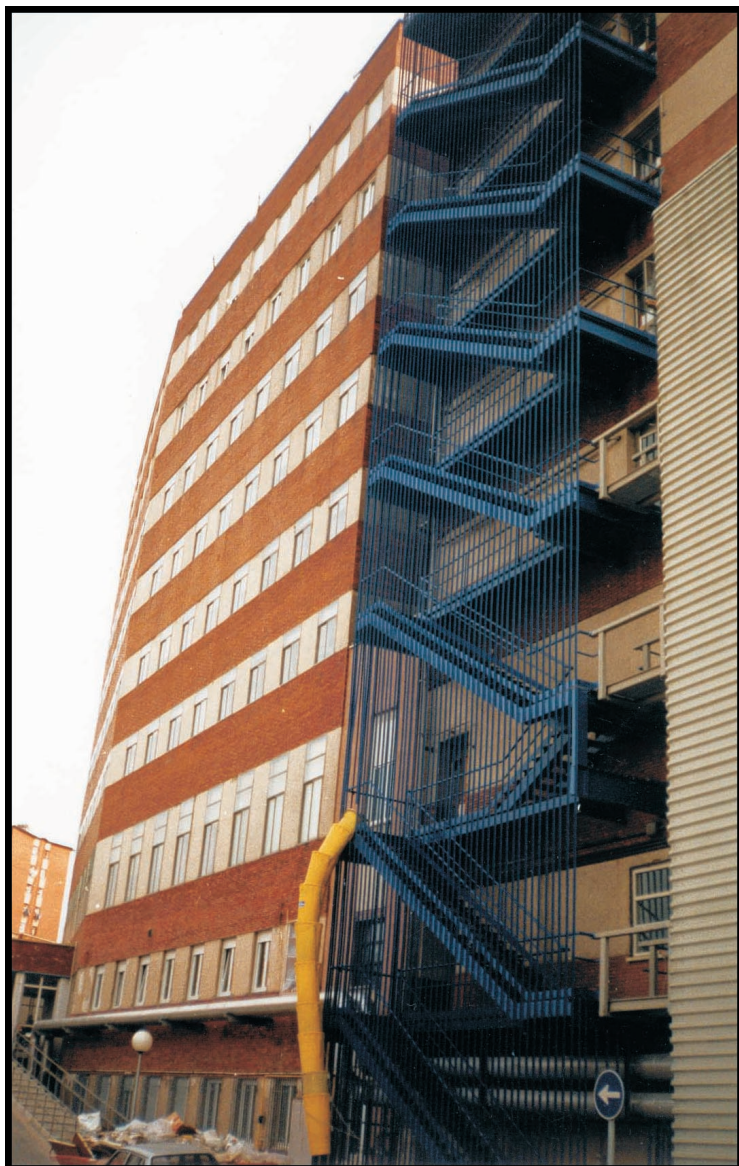
Due to the effects of the environment and time, the external emergency staircase at this hospital was suffering from severe corrosion, as can be seen from the photograph.

The corroded areas were suitably prepared and coated with our anti-corrosive epoxy Corro-Tech GP, ideal for the protection of new and existing steel structures where preparation is restricted. Two coats of Uni-Tech UV were then applied.

Uni-Tech UV is a two component, solvent-based polyurethane coating which offers outstanding colour and gloss retention.

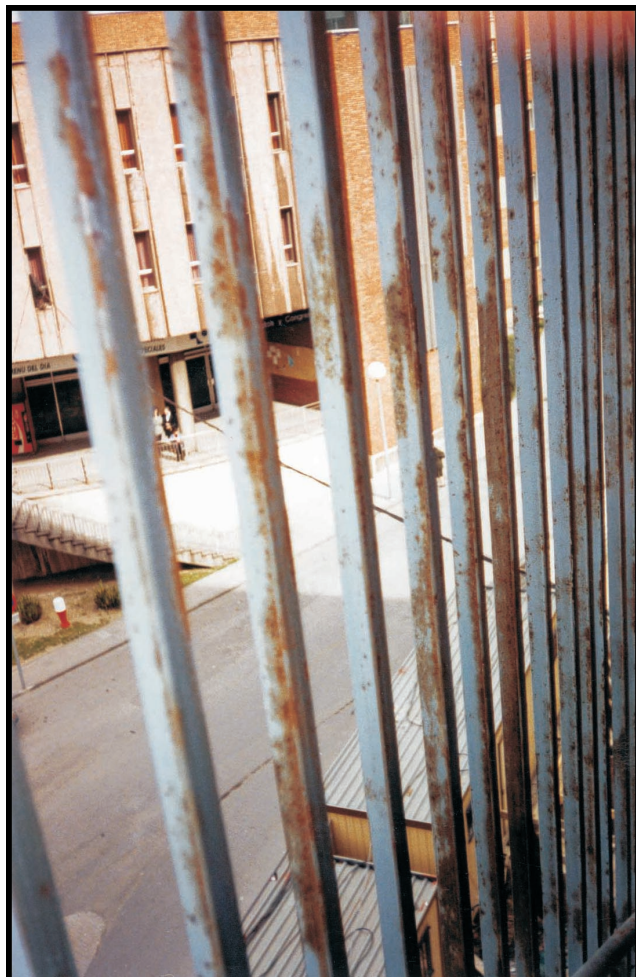
The client was pleased with the results.
