## PROJECT PROFILE

**PROJECT:** Fire Escape Stairway

**LOCATION:** Spain

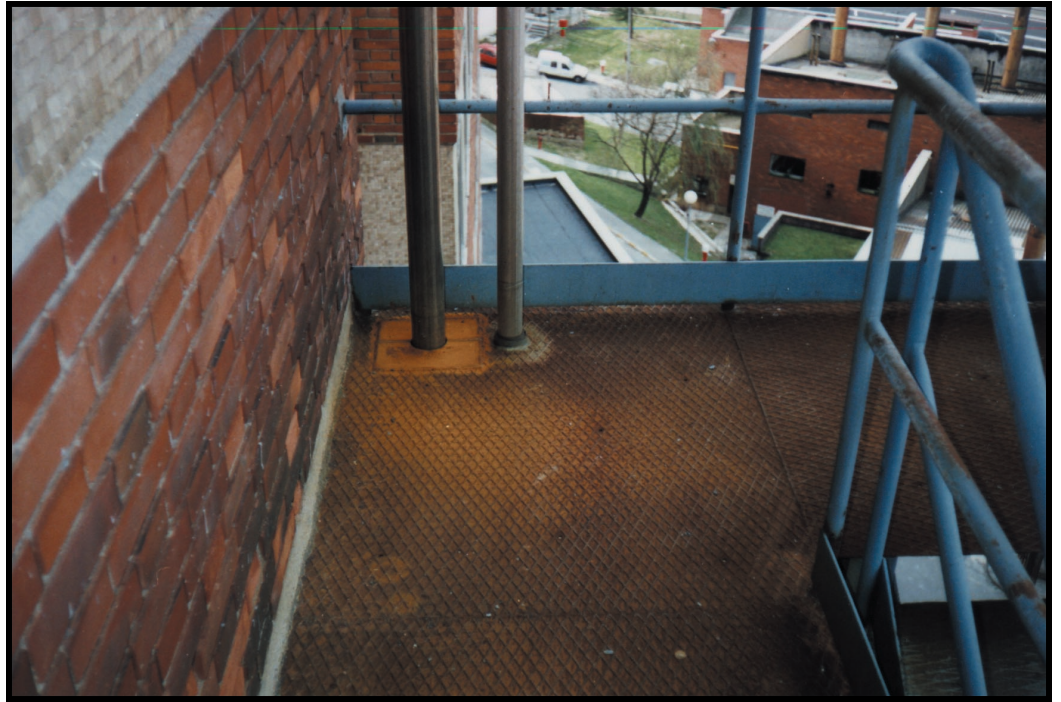
The fire escape external staircase in this hospital was very badly corroded.

This was creating a safety hazard as well as reflecting badly on the hospital's image.

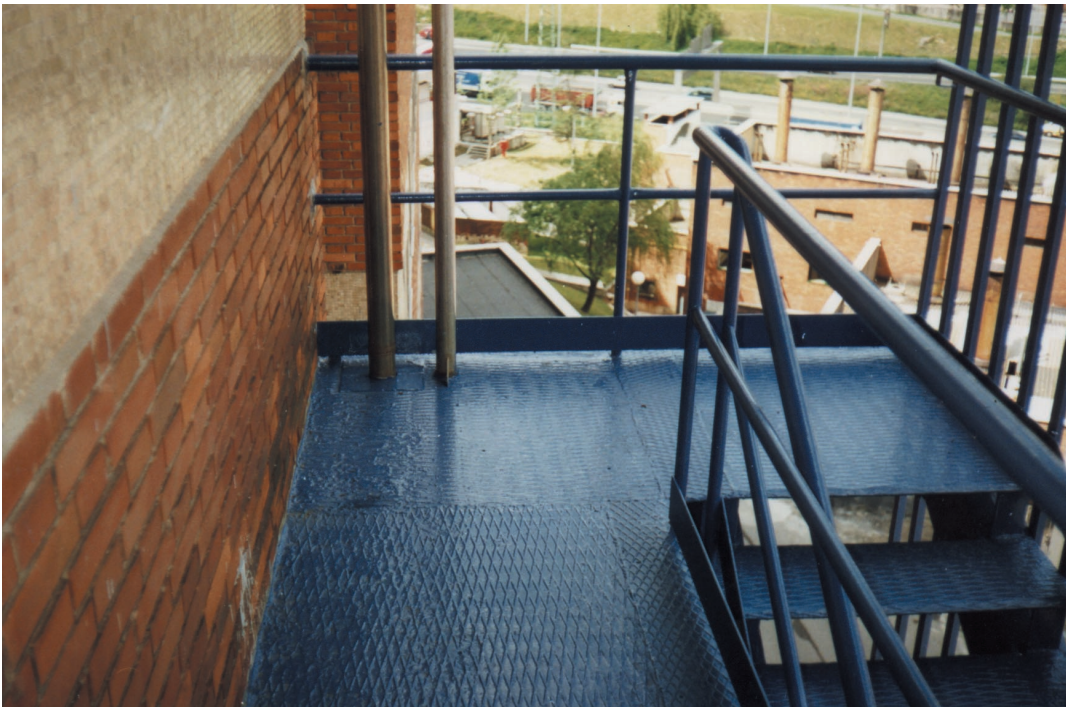
This has both protected the fire escape and improved its overall appearance.

It was only possible to manually prepare the fire escape.

After the surface had been manually prepared, one coat of Corro-Tech GP Primer and two coats of Uni-Tech UV in blue were applied.
