PROJECT PROFILE

PROJECT: Operating Theatre Refurbishment
LOCATION: Spain

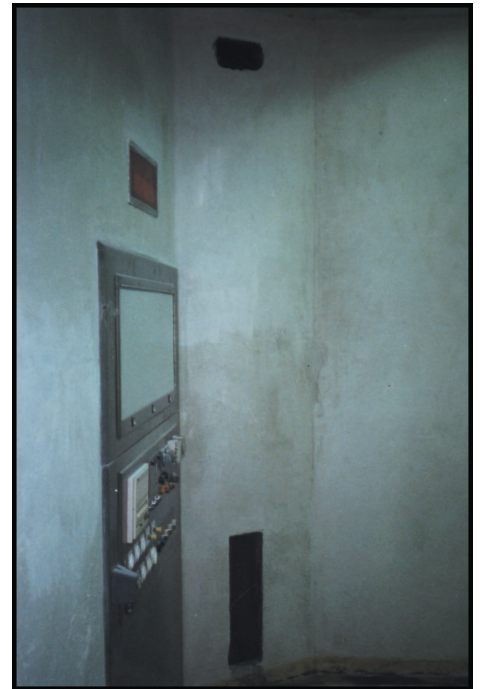
The internal walls and ceiling of this operating theatre were in an extremely bad condition.

Due to the condition of the walls and ceiling, the operating theatre had been shut down, resulting in high costs for the customer.
