## PROJECT PROFILE

**PROJECT:** Hospital Refurbishment  
**LOCATION:** Spain

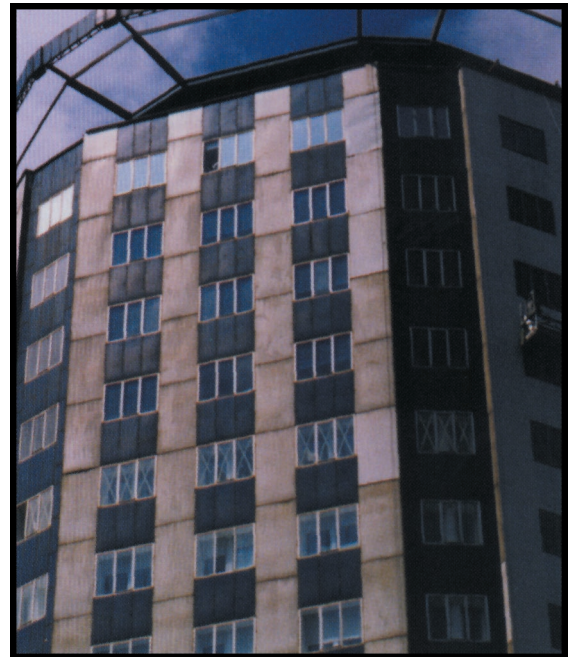
The external walls of this hospital building in Spain were a cementitious cladding system. As is apparent from the photograph, these panels had deteriorated badly over a period of time and were severely staining the surface. This was causing contamination to the exterior of the building, including damage to the window frames.

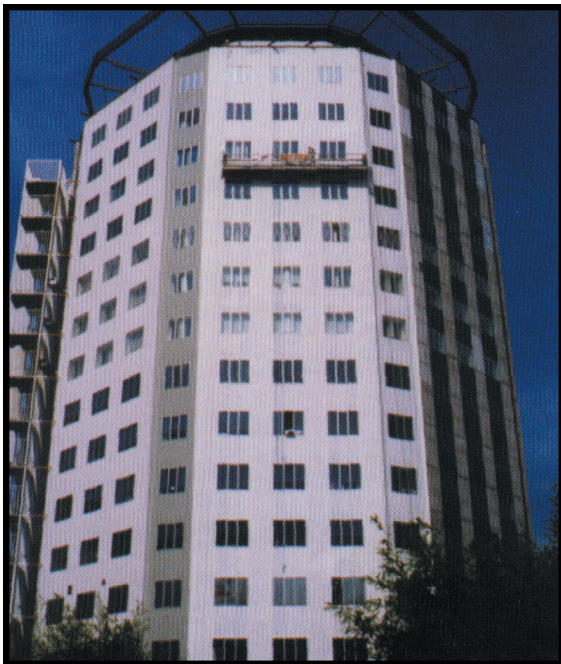
The finish has completely transformed the external appearance of this building. The client is delighted with the finish that has been achieved.

The entire external surface of the building was first of all cleaned to remove all dirt. All loose and friable concrete was removed to provide sound surfaces. Any areas that needed rebuilding were first rebuilt with Wall-Tech LW. The entire surface was then protected with the Wall-Tech PU system in white and light grey.
