PROJECT PROFILE

PROJECT: Cooling Tower Refurbishment
LOCATION: Canada

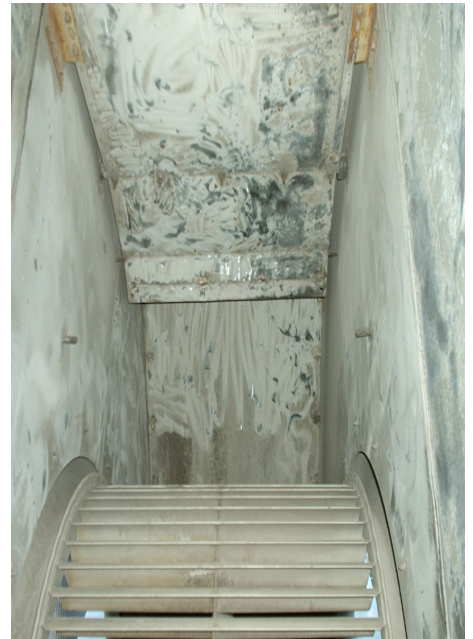
One of the cooling towers at this client's hospital facility was scheduled for maintenance during the seasonal shutdown. Upon inspection, it was determined that the internal exposed surfaces were corroding badly and required re-lining.

In addition, both the external and internal joints had been leaking and corrosion was also prevalent in these areas.
